INDOOR AIR QUALITY ASSESSMENT

**Littleton Middle School
55 Russell Street
Littleton, Massachusetts**

Prepared by:
Massachusetts Department of Public Health
Center for Environmental Health
Emergency Response/Indoor Air Quality Program
August 2005

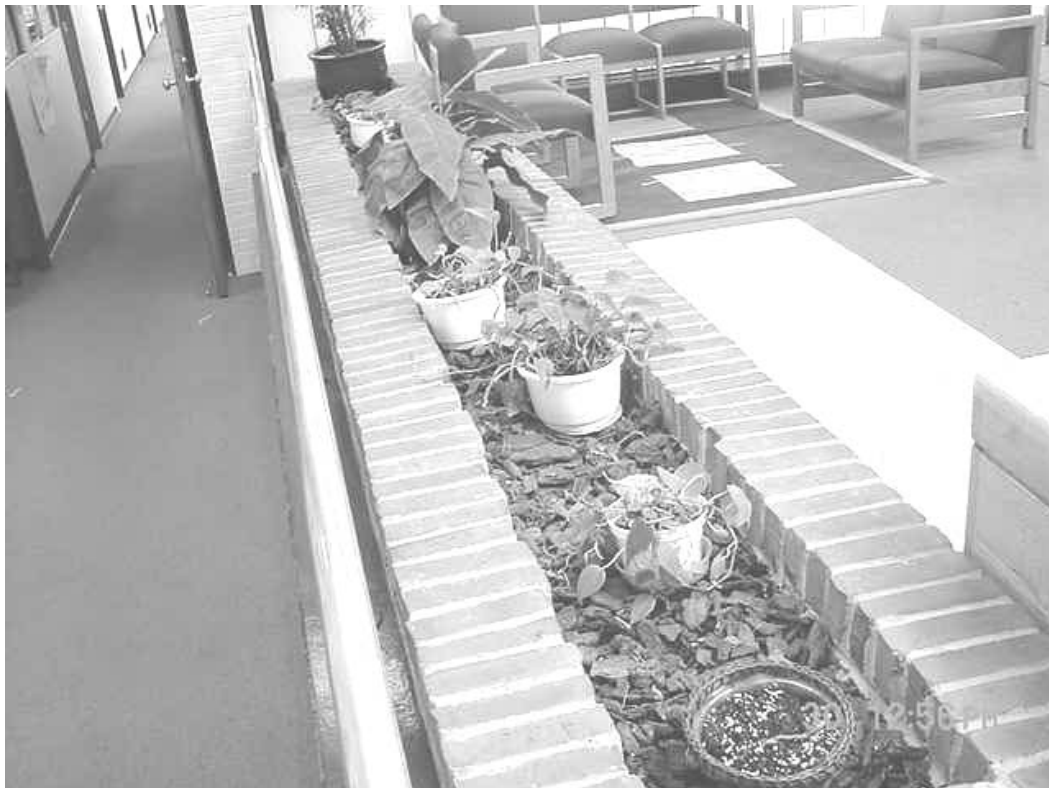
Picture 28

Several areas had a number of plants. Moistened plant soil and drip pans can be a source of mold growth (Picture 27). Of particular note was a large indoor planter in the main lobby (Picture 28). This large indoor planter is constructed of brick and did not appear to have a means for drainage. Plants are also a source of pollen. Over watering of plants should

Large Indoor Planter in Main Lobby

6. Ensure all plants are equipped with drip pans. Avoid over watering and examine drip pans periodically for mold growth. Disinfect with an appropriate antimicrobial where necessary. Move plants away from ventilation sources in classrooms.

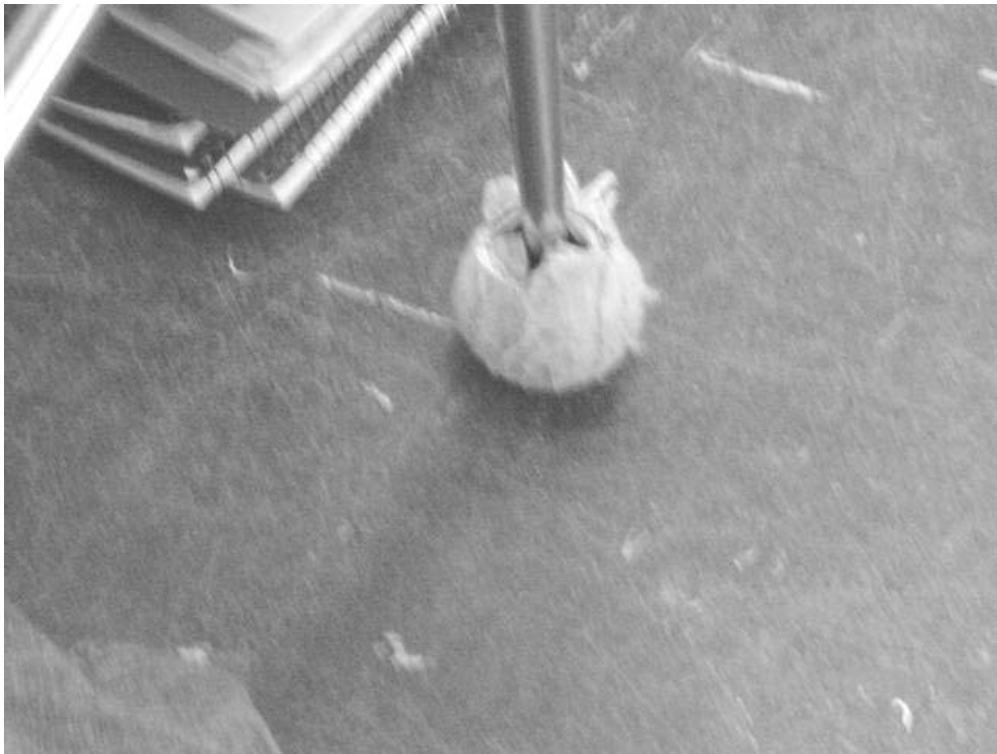
Picture 29

In an effort to reduce noise from sliding chairs, tennis balls had been sliced open and placed on chair legs (Picture 29). Tennis balls are made of a number of materials that are a source of respiratory irritants. Constant wearing of tennis balls can produce fibers and cause TVOCs to off-gas. Tennis balls are made with a natural rubber latex bladder, which becomes abraded when used as a chair leg pad. Use of tennis balls in this manner may introduce latex dust into the school environment. Some individuals are highly allergic to latex (e.g., spina bifida patients) (SBAA, 2001). It is recommended that the use of materials containing latex be limited in buildings to reduce the likelihood of symptoms in sensitive individuals (NIOSH, 1997). A question and answer sheet concerning latex allergy is attached as [Appendix B](#) (NIOSH, 1998).

Tennis Ball on Chair Leg

7. Clean air diffusers, exhaust/return vents and personal fan blades periodically of accumulated dust.
8. Consider discontinuing the use of tennis balls on chairs to prevent latex dust generation.

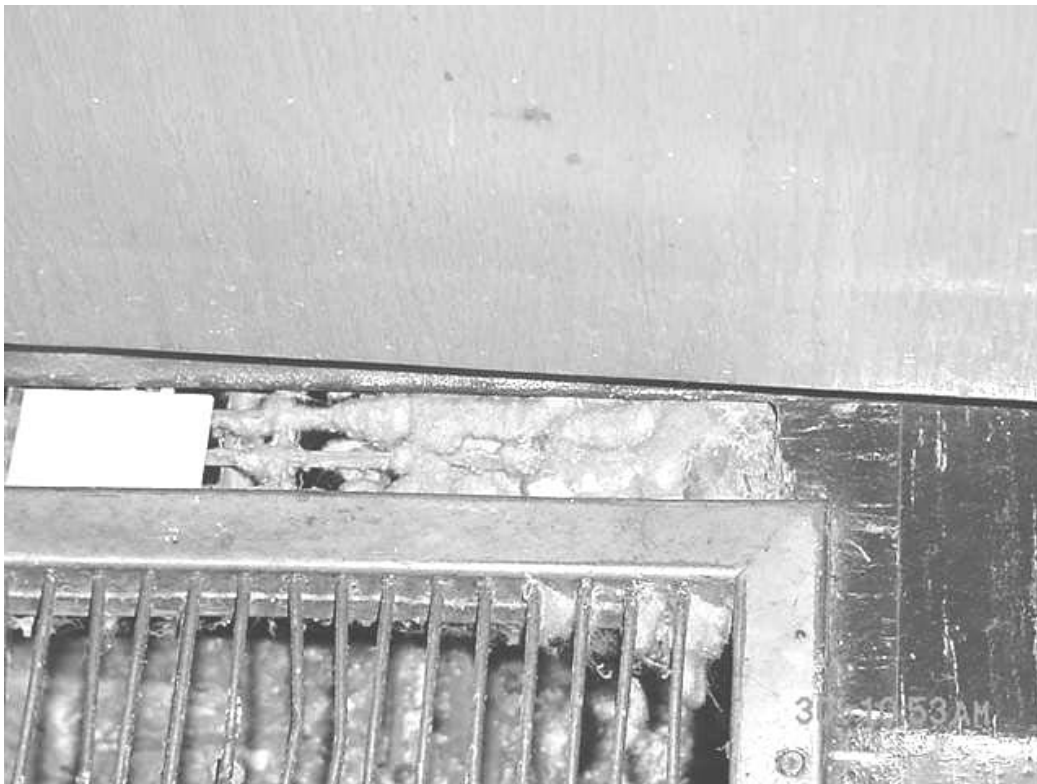
Picture 30

Supply diffusers, return vents and fan blades to personal fans were occluded with dust (Picture 30). Reactivated fans and AHUs can serve to distribute accumulated dust. If exhaust vents become deactivated, backdrafting can result in the re-aerosolization of accumulated dust particles. Dust can be irritating to the eyes, nose and respiratory tract. Flat surfaces should be wet wiped and cleaned with a vacuum equipped with the high efficiency particulate arrestance (HEPA) filter on a regular basis.

Dust and Debris Occluding Floor (Return) Vents
